Landslide Control Program at the Panama Canal

ABSTRACT

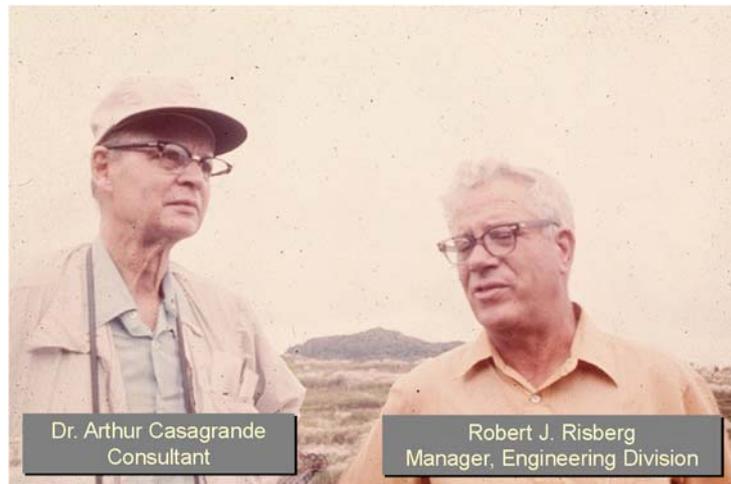
In May 1968, at the beginning of the rainy season, the Canal was threatened by a major incipient landslide. Hodges Hill, a Canal slope in Gaillard Cut, developed cracks about 2 meters across, just north of the Continental Divide and was in imminent danger of completely blocking Canal traffic for a month or more. A board of prominent consultants, among which was Arthur Casagrande, was convened to recommend a solution to the crisis. They recommended a stabilization plan consisting of nineteen horizontal drains drilled into the hill from the bank of the Canal, together with extensive drainage

Figure 2: Inspection at Hodges Hill Landslide - Beginning of Modern Landslide Control Program (1968)

systems installed on the upper slopes to divert runoff from the ground cracks. This action was implemented at a cost of \$400,000, much lower than the \$10 million considered necessary initially for a massive remedial excavation.

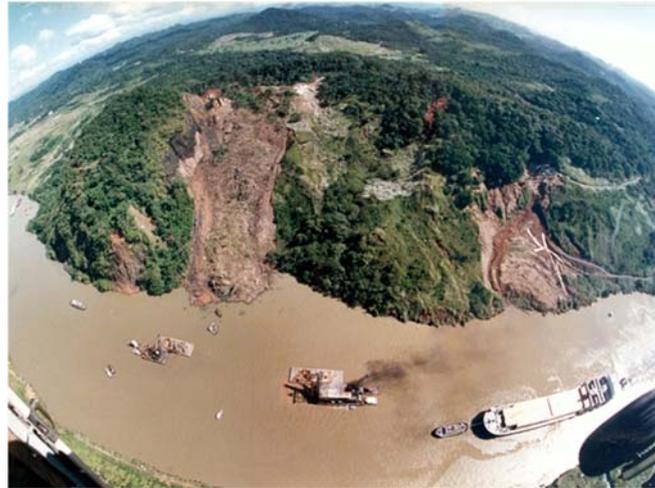
In Figure 7, the year 1986 stands out from the rest with a total cost of 41.7 million dollars due mostly to the historical reactivation of East Cucaracha Slide on October 13th. The total volume of the stabilization works was about 3.5 million cubic meters. Of this volume, approximately 400,000 cubic meters fell into the navigation channel and were dredged (see Figure 8).

Figure 8: East Cucaracha Slide Reactivation of October 13, 1986

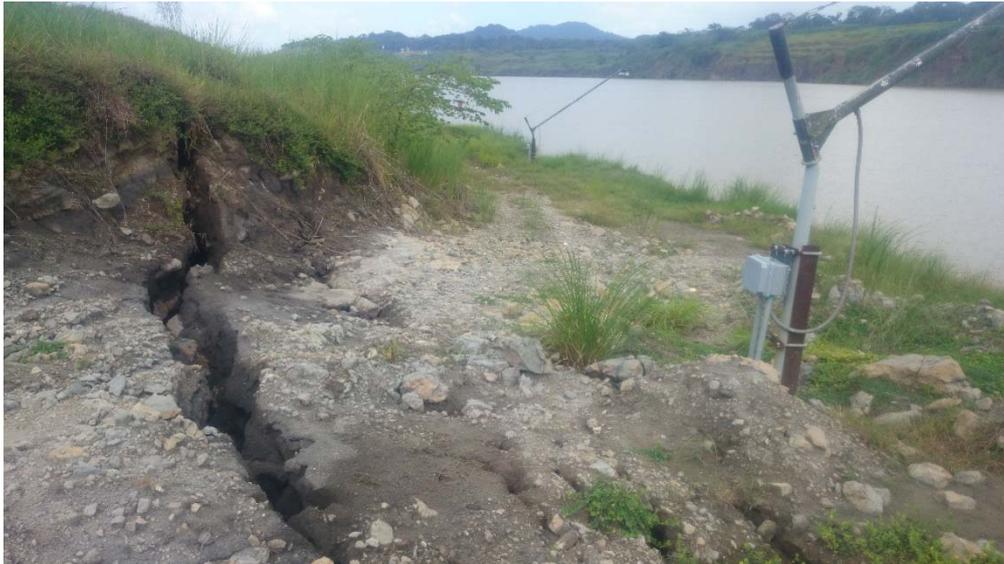
The slide being studied occurred on December 7th, 2015. Several cracks were reported in the area (see Figure 12). Two days later, on December 9th, the Manager of the Geotechnical Branch activated the Landslide Response Protocol issuing an “imminent landslide” (Code Yellow) alert for this area.

The unstable mass was estimated to be 500 meter long and 200 meter wide, comprising approximately 2 million cubic meters. The potential encroachment was estimated to reach 50 meters into the west lane of the navigational channel.

Figure 12: Tension Cracks at Old Lirio Slide Area

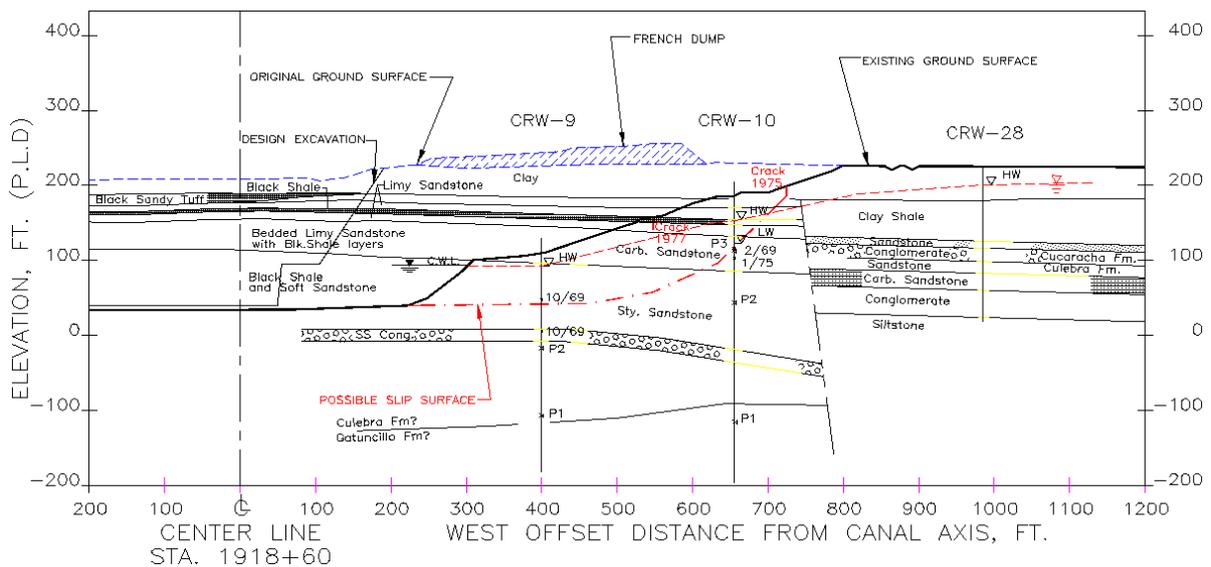
In both, the June 2013 and the December 2015 events, the failure mechanisms were considered to be rotational, with a slip surface extending through layers of fill, clay shale, sandstone, conglomerate, and carbonaceous sandstone (see Figure 13).

Figure 13: Geological Cross Section at Station 58K+479 m (1918+60 feet)

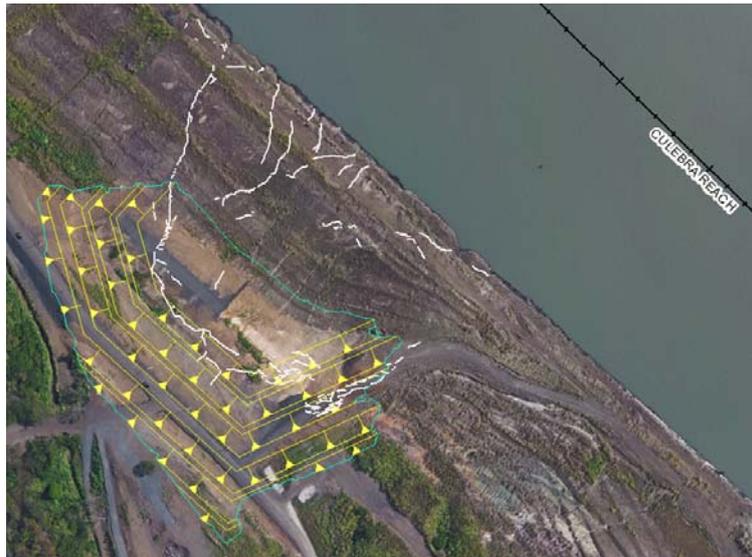
Figure 14: Excavation Layout at Old Lirio Slide

According to the Landslide Response Protocol guidelines, the instrument data was further analyzed. No additional geological or geotechnical investigations were required in this case. The remedial works were designed and implemented to stabilize the area. The works initiated on January 4, 2016. They were performed by ACP internal forces under the direction of the Geotechnical Branch and were completed by February 2017, after a 5-months interruption due to rainfall between July 2016 and January 2017. The works comprised the excavation of 204,000 cubic meters of unclassified material, the construction of a set of drainages with a total length of 170 meters, an inverted filter covering approximately 1825 square meters, and a french drain of about 168 meters long. No dredging works were required. Figure 14 shows the final excavation layout of the stabilized area in yellow, the excavation perimeter is shown in cyan, and the mapped cracks are shown in white.

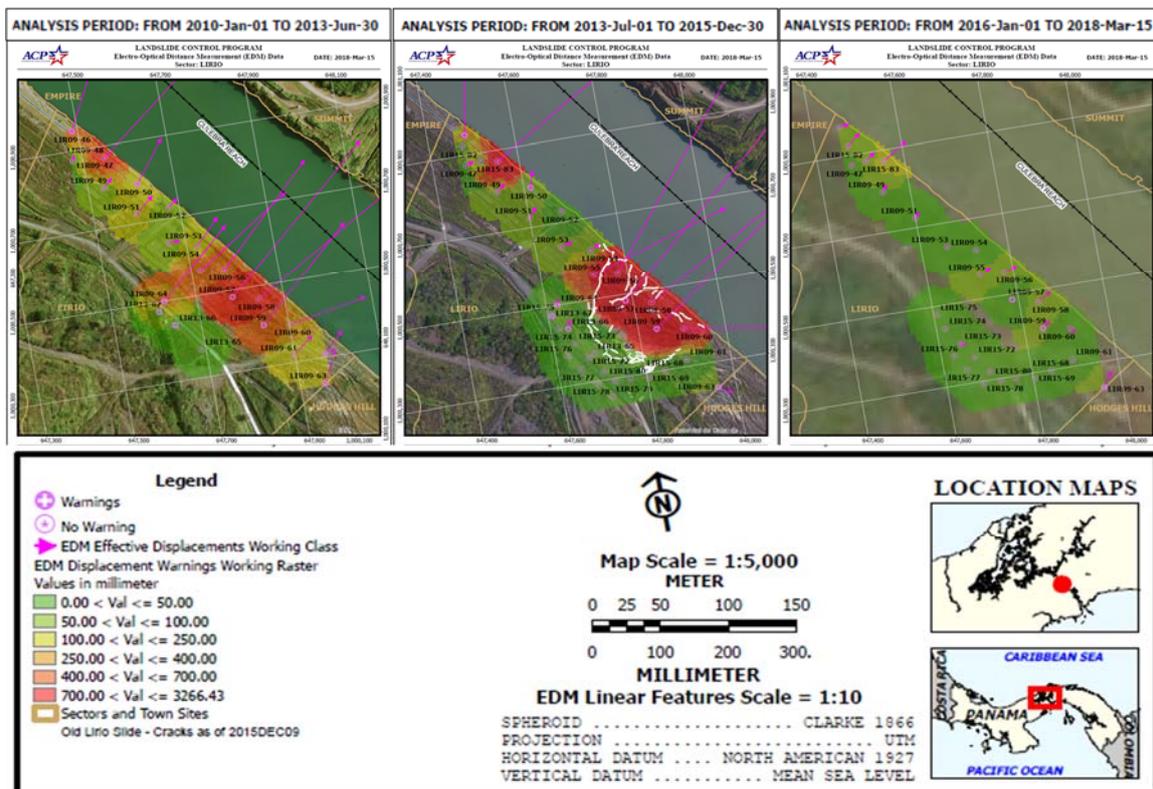
Figure 15 presents a set of plan views showing color-classified raster images representing superficial displacements at the Old Lirio Slide area, and the corresponding vectors representing effective displacement in magenta. The first plan view shows data for the period beginning on January 1, 2010 and ending on June 30, 2013; some days after the June 2013 instability. The second plan view covers the period between July 1, 2013 and December 30, 2015, less than a month after the December 2015 landslide. The third raster shows the data indicating recorded displacements since January 1, 2016 up to March 15, 2018.

Figure 15: Displacement Vectors and Raster Images at Old Lirio Slide

Displacement vectors for the different monuments shown in the first plan view of Figure 15 indicate an average movement of about 1 meter that had accumulated for over three years before the June 2013 landslide occurred. Remedial works were performed for the next six months to stabilize the moving mass, including the removal of the material at the top of the moving mass and the construction and rehabilitation of drainages in the area. Even after the stabilization works were completed, movement towards the canal continued, and the new tension cracks developed by December 2015, shown on the second plan view in white, time at which the Landslide Response Protocol was reactivated and Code Yellow notifications were issued. New remedial works were executed as described previously, preventing any channel encroachment. The third plan view shows displacements smaller than 50 millimeters for most of the area, corroborating the landslide hazard has been mitigated.

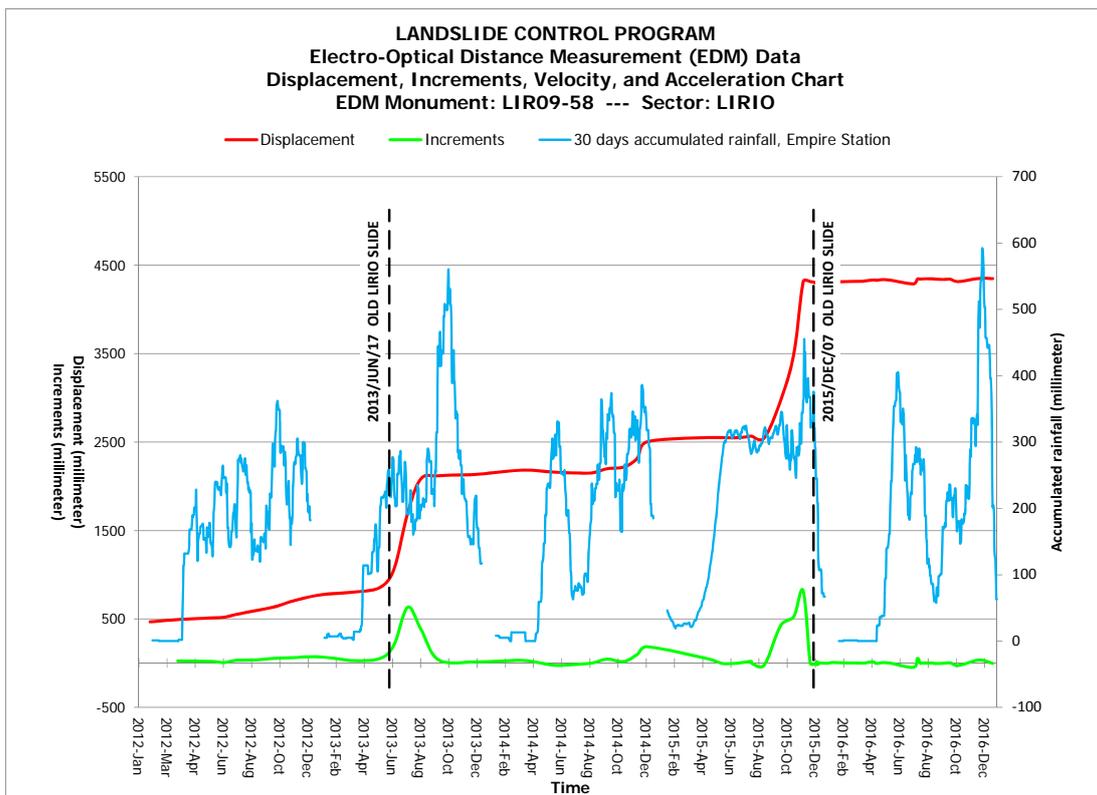
Figure 16: Effective and Incremental Displacement vs. 30-Day Accumulated Rainfall

Figure 16 shows a comparison between data for the effective and incremental displacements of Monument LIR09-58 and the 30-day accumulated rainfall, as recorded at the nearest meteorological station (Empire). The chart shows that the landslides mentioned above occurred during periods of heavy rainfall. Worth noting, the larger movements developed during the sustained periods of rain, which favor water infiltration and the consequent increase in water table and pore pressure, and not necessarily during the peaks of rain intensity, as shown.
