# HISTORICAL QUAY WALL RENOVATION IN ANTWERP, BELGIUM

**Abstract:** The historical quay walls of the river Scheldt are a major landmark of Antwerp. After almost 150 years of continuing instabilities, the right bank quays are stabilized along their entire length. This durable renovation project, being challenging in its own right from a geotechnical point of view, is further complicated by the requirement to preserve the historical bluestone facing as well as the historical position ('quay line') of the quays. Innovative techniques are devised to restore the Scheldt quays to their old glory in a cost efficient way. The works are currently ongoing in several zones, two of which are discussed as case studies in this paper.

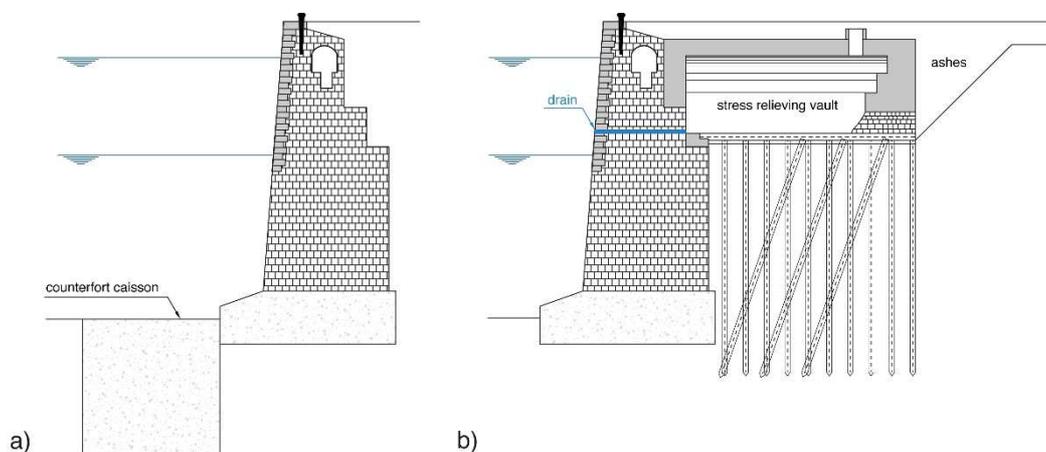
**Figure 3: Remedial measures to limit horizontal movements with (a) counterfort caissons in front of the quay wall or (b) stress relieving vaults behind the quay walls**

- To increase the sliding resistance, additional counterfort caissons have been placed in front of the quay walls in large stretches of the quays. Sometimes, clay or blast furnace slag embankments were placed in front of the quay walls as a permanent measure as well.
- To alleviate the risk of tilting, additional drains and stress relieving vaults were installed behind the upper parts of the gravity walls. In several areas, the soil behind the quay walls was removed and replaced by lighter materials such as ashes. Exceptionally, the soil behind the quays was permanently excavated, making the quay in this zone useless for any activity.

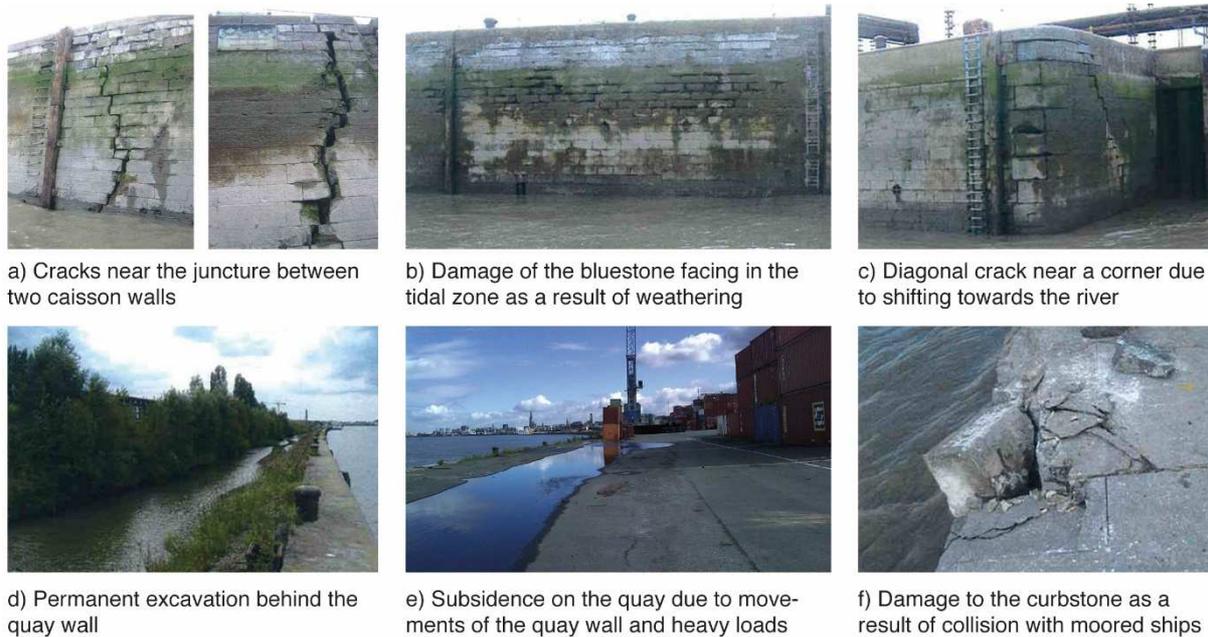
**Figure 4: Inspection of damage phenomena on the Scheldt quay walls**

It is clear that not all the recorded damage was due to the instability of the gravity walls, e.g. cases (b) and (f) in Figure 4. Nevertheless, the renovation of the quays is seized as an opportunity to tackle all observed damage phenomena for the future.

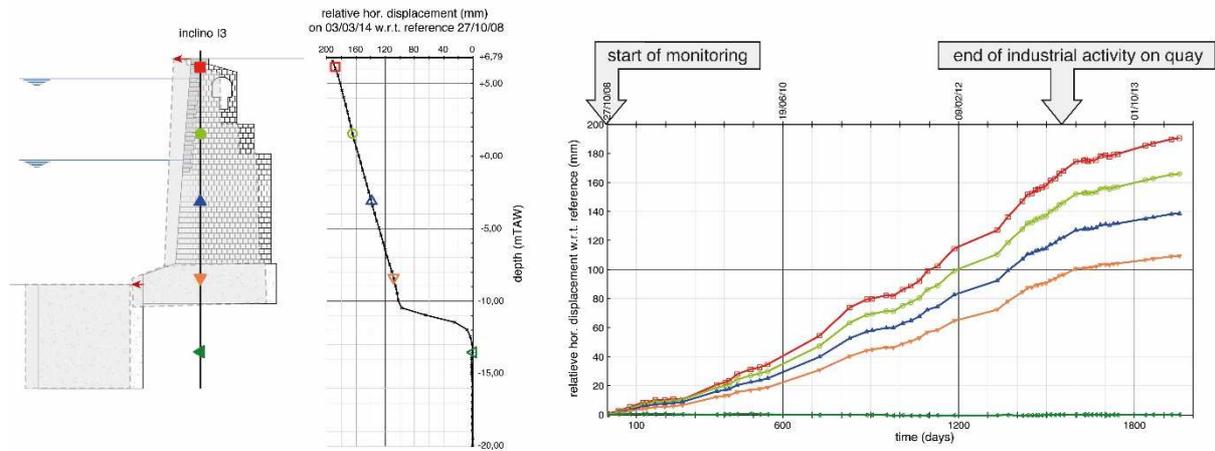
In 2011, the restrictions were intensified but by September 2012 progressively worsening displacements could still be observed. In one measurement even a tilting of the walls was diagnosed, as shown in Figure 5. As a result, all industrial activities on the quays were prohibited with immediate effect in this area.

Other remedial measures included the installation of a clay berm in front of the gravity walls and eventually even the excavation of soil behind the quays to alleviate the active soil pressures, as shown in Figure 6. Despite these drastic measures the shifting and tilting continued, albeit at a slower rate as shown in the inclinometer results in Figure 5.

**Figure 5: Relative horizontal displacements as a function of depth and time from inclinometer measurements inside the quay wall at D'Herbouvillekaai**

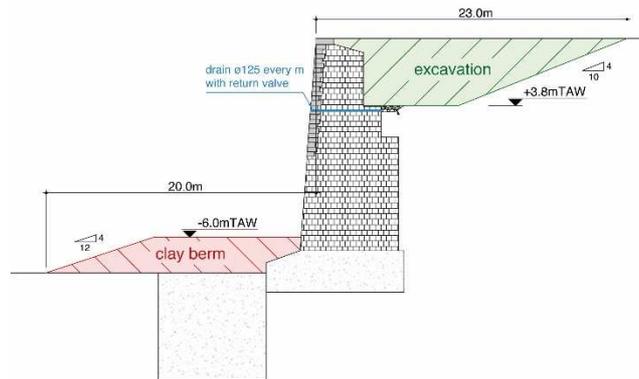
**Figure 6: Drastic remedial measures along D'Herbouvillekaai in 2012: clay berm and drained excavation**

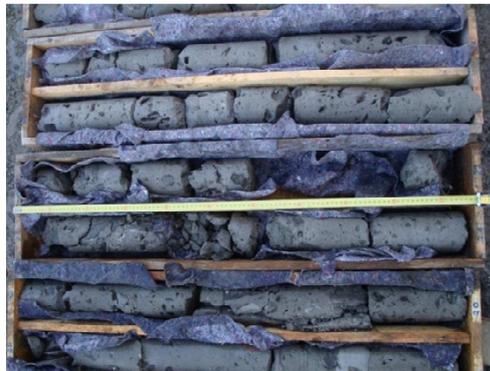
Already during the first jet-grouting operations, problems were encountered. The spoil return flow at the top of the drill hole was not continuous. The quality of the large diameter grout columns was investigated with core drill holes. Many clay inclusions were found along the entire depth of the grout columns, as shown in Figure 13. The formation of these inclusions was attributed to the properties of the tertiary Boom clay. Due to the high stiffness and plasticity of this pre- and overconsolidated clay layer, it seemed impossible with large diameter jet-grouting to cut loose clay particles that are small enough to travel through the ring gap in the drill hole. As a result, clay chunks block the ring gap in the drill hole and pressure is built up, within seconds, in the subsoil. The spoil is then directed to alternative low resistance paths, e.g. via the bottom of the caissons, and the quality of the grout columns is drastically reduced. In addition, during jet-grouting operations, the movement of the quay wall was monitored continuously. Even after successfully executing the first series of grout walls, unacceptable movement of the historical quay wall was monitored during jet-grouting operations.

**Figure 13: Core drill holes of the jet-grout columns at De Gerlachekaai with clearly visible clay inclusions**

About 20 different sets of jet-grouting parameters were tested, but none of them gave satisfying results. In the end, it was decided that the performance of the grouting technique was too uncertain in the Boom clay and this stabilization technique was completely abandoned.
