# HISTORICAL QUAY WALL RENOVATION IN ANTWERP, BELGIUM

**Abstract:** The historical quay walls of the river Scheldt are a major landmark of Antwerp. After almost 150 years of continuing instabilities, the right bank quays are stabilized along their entire length. This durable renovation project, being challenging in its own right from a geotechnical point of view, is further complicated by the requirement to preserve the historical bluestone facing as well as the historical position ('quay line') of the quays. Innovative techniques are devised to restore the Scheldt quays to their old glory in a cost efficient way. The works are currently ongoing in several zones, two of which are discussed as case studies in this paper.

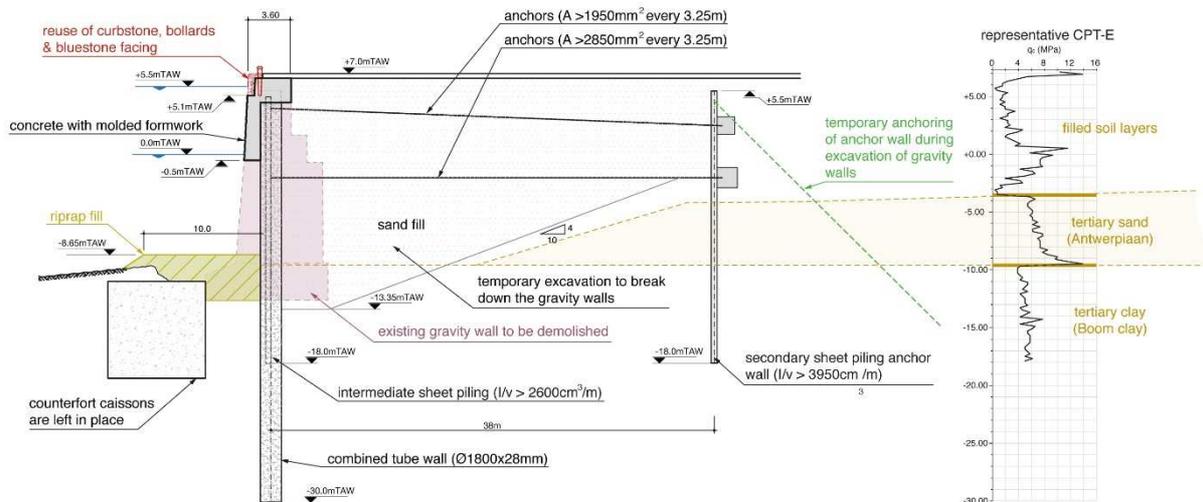
The deteriorating state of the already damaged quay walls numbered down the options for renovation drastically. Any solution considering the reuse of the existing quay walls in the future had to be disregarded for several reasons. First of all, there was no room for experimentation with new techniques in the area. The mere fact that an implicitly uncertain technique would have to be carried out in close vicinity of the already unstable quays was inadvisable. Furthermore, the overall stability in any of the scenarios with reuse would always somehow depend on the structural integrity of gravity walls in their

**Figure 7: Stabilization design along D'Herbouvillekaai**

In the end, the only viable and durable solution was the radical reconstruction of the quay walls, at the exact historical position, as shown in Figure 7. The existing gravity walls are entirely demolished (including the pneumatic foundation caissons) and replaced by a tube combined retaining wall with 37.5m long steel tubes. Two rows of anchors are attached to an anchor wall located 38m inland. This sheet piling wall is used as retaining wall during the construction phase. The river bed near the toe of the combined wall is protected with a rocky debris fill. Any original counterfort caissons present in the river bed are left at their current location. Removing them would influence the stability of the new retaining walls in a negative way.

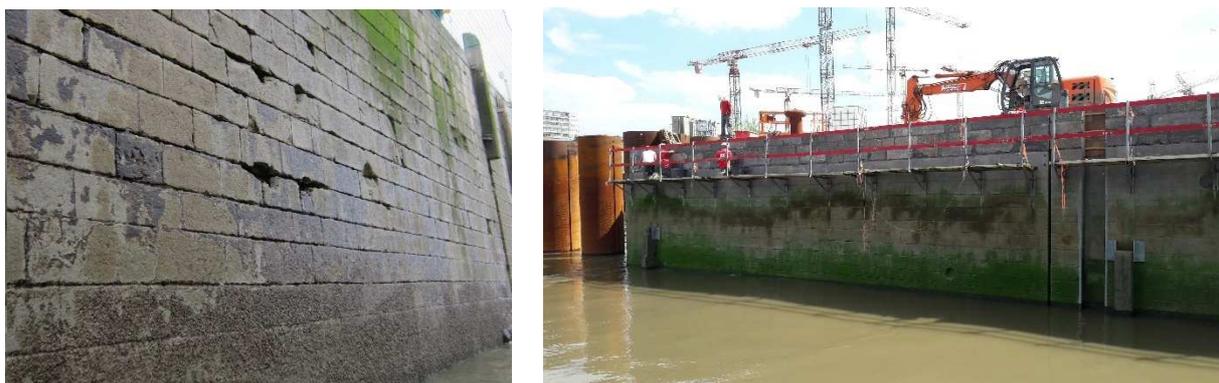
A detailed photogrammetry showed that it is unfeasible to reuse all bluestone blocks since many stones in the tidal area have weathered and broken over the last century (cfr. Figure 4b). Moreover, a lot of blocks, visually in a good state when still at place, decomposed during or shortly after removing them out of the historical masonry. Because too many stones had become too brittle to reuse, the following innovative solution was introduced to maintain the look of the historical quay walls.

**Figure 8: Original bluestone facing (left) and new concrete molded formwork with on top three rows of reused blue stone blocks (right)**

Under the high water line, concrete walls are installed of which the outer formwork is a mold of the original bluestone masonry, see Figure 8. This mold is made on site to preserve the original look of the quays. This approach was approved by cultural heritage given the fact that most of the concrete surface will be covered with mossy and muddy deposition in the tidal zone over time, eventually resembling the current state of the quays. There are several additional advantages:

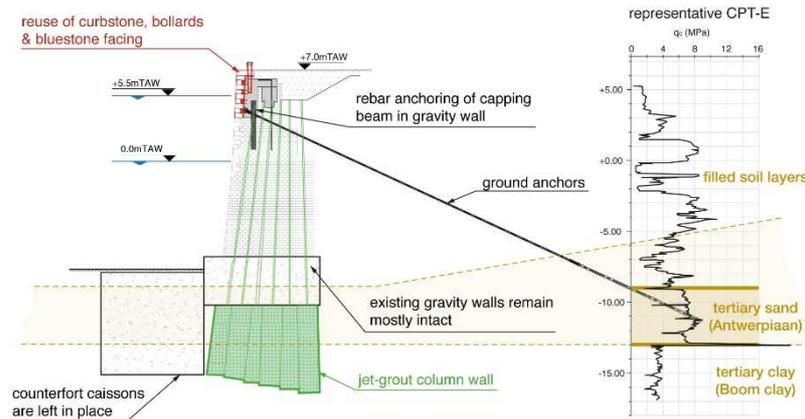
While this remedial technique is much less invasive, it is also more risky. The jet-grouting had to be performed at very large depth, in a very stiff clay layer, underneath the historical structure. As a result, the quality of the grouting operation was difficult to control. It was therefore decided to perform the stabilization in a test section first to assess the efficiency of the proposed design.

**Figure 12: Stabilization design with jet-grouting in test phase**

Already during the first jet-grouting operations, problems were encountered. The spoil return flow at the top of the drill hole was not continuous. The quality of the large diameter grout columns was investigated with core drill holes. Many clay inclusions were found along the entire depth of the grout columns, as shown in Figure 13. The formation of these inclusions was attributed to the properties of the tertiary Boom clay. Due to the high stiffness and plasticity of this pre- and overconsolidated clay layer, it seemed impossible with large diameter jet-grouting to cut loose clay particles that are small enough to travel through the ring gap in the drill hole. As a result, clay chunks block the ring gap in the drill hole and pressure is built up, within seconds, in the subsoil. The spoil is then directed to alternative low resistance paths, e.g. via the bottom of the caissons, and the quality of the grout columns is drastically reduced. In addition, during jet-grouting operations, the movement of the quay wall was monitored continuously. Even after successfully executing the first series of grout walls, unacceptable movement of the historical quay wall was monitored during jet-grouting operations.

In a first design effort, a stabilization technique with transverse grout walls below the current gravity walls was considered as shown in Figure 12. Five parallel and equidistant shear panels were foreseen per foundation caisson to extend the foundation depth. Each shear panel consisted of multiple cylindrical VHP jet-grout columns with a large diameter. The jet-grout columns were constructed after drilling through the existing masonry walls and foundation caissons from the quay platform. They were armoured with rebar steel upon completion. Before the jet-grouting started, all voids and cracks intersecting with the drill holes were gravitationally injected with a cement grout. Additionally, ground anchors had to be installed to limit the horizontal movements of the quay walls. An integrated concrete capping beam with bluestone façade was constructed at the top of the gravity wall. The joints between adjacent caissons under the low water line were repaired.

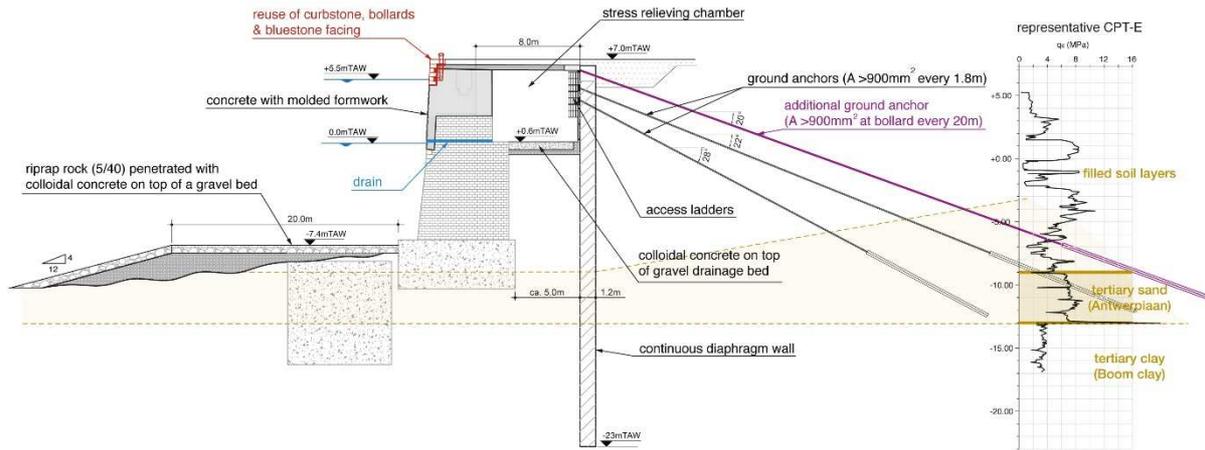
**Figure 14: Stabilization design for De Gerlachekaai**

A more expensive but more controllable design was developed for this area of the quays. In the optimized design, which also preserves a big part of the historical wall, a diaphragm wall is installed behind the quay walls, as shown in Figure 14. The diaphragm wall is embedded in the Boom clay at a depth of -23mTAW. The horizontal stability of the diaphragm wall is ensured with 2 rows of ground anchors every 1.8m. An additional ground anchor is installed every 20m at the location of a bollard.

Between the original gravity wall and the diaphragm wall, stress relieving chambers are additionally installed to reduce the loads on the original gravity wall. Four drainage tubes per caisson are drilled through the original masonry wall to allow the stress relieving chambers to follow the tide in the river Scheldt.
